CRISIS MANAGEMENT – Pilotage in Challenging Circumstances

Considerations and challenges when Risk Assessing an unusual Situation

V DUE - Liverpool, UK – 2016

FREMANTLE HIGHWAY – Holland, 2023

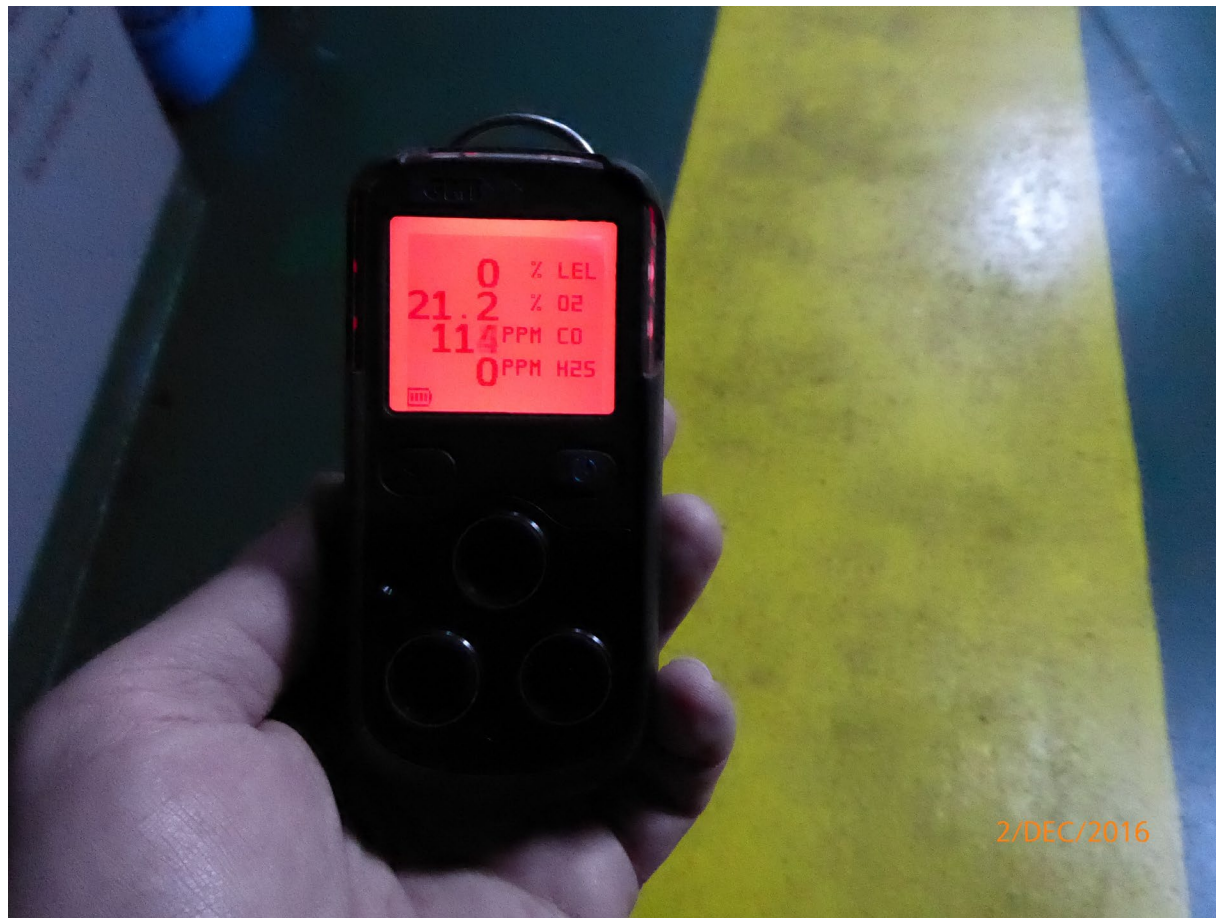
2016.12.03

Salvors onboard Gas Reading on Deck

CO 114PPM adjacent to Hatch Cover

Smoke escaping through seals from overpressure in hold

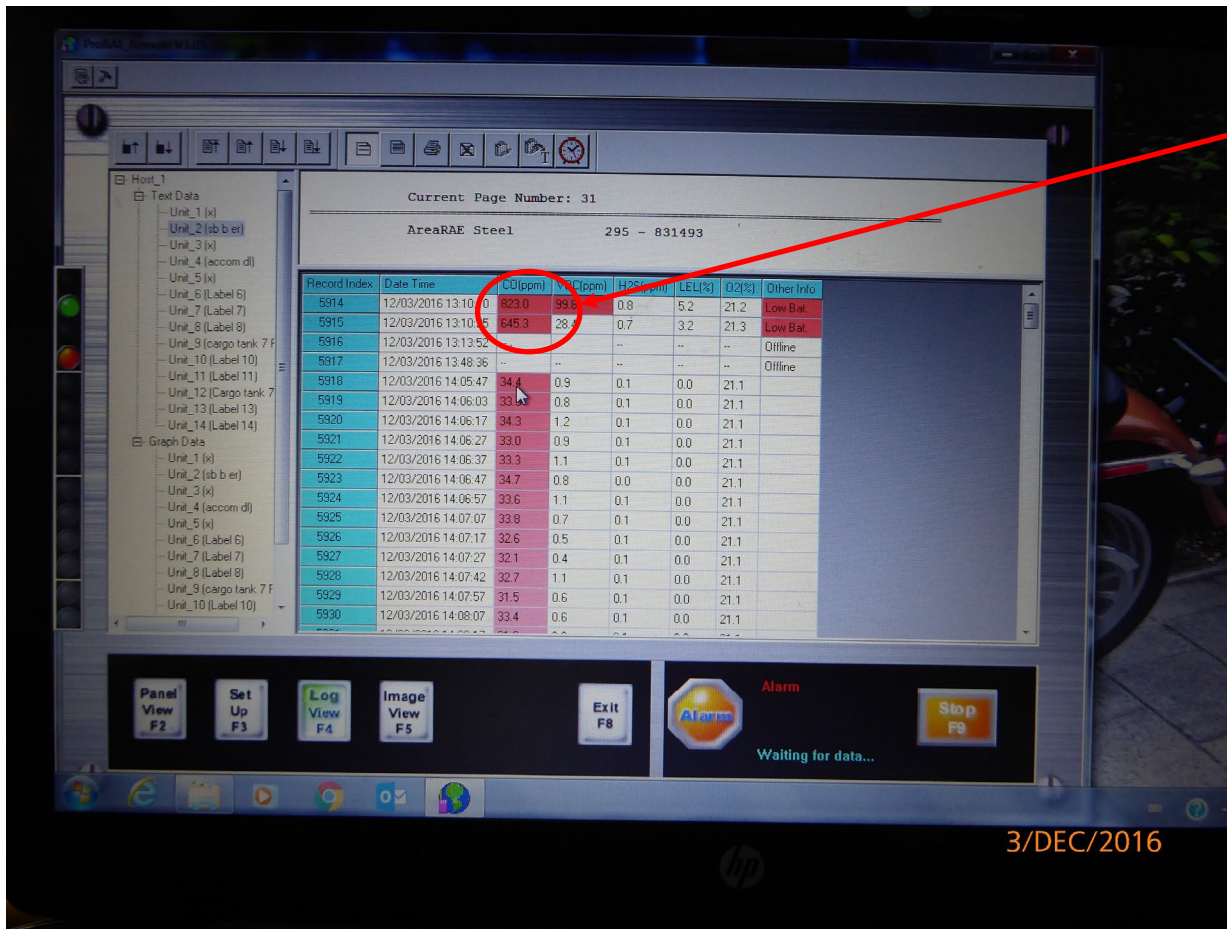
Engine Room CO - 823ppm & 645ppm

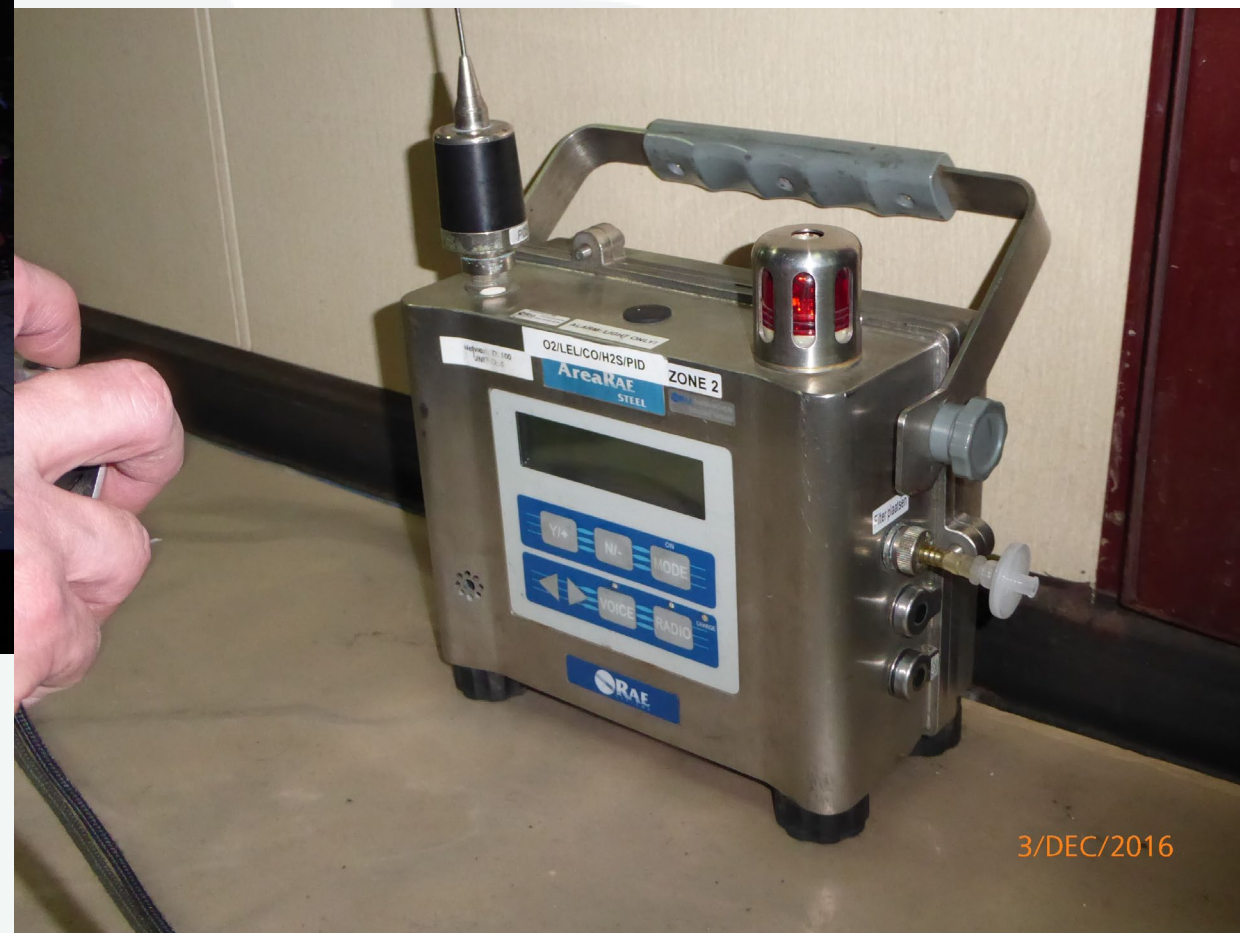
2016.12.03

Salvors (VdP) install Gas Measuring AreaRae equipment onboard
CO MAX of 823PPM recorded in Engine Room Spaces

Entry into Engine Room under SCBA with Salvor Assisting Only

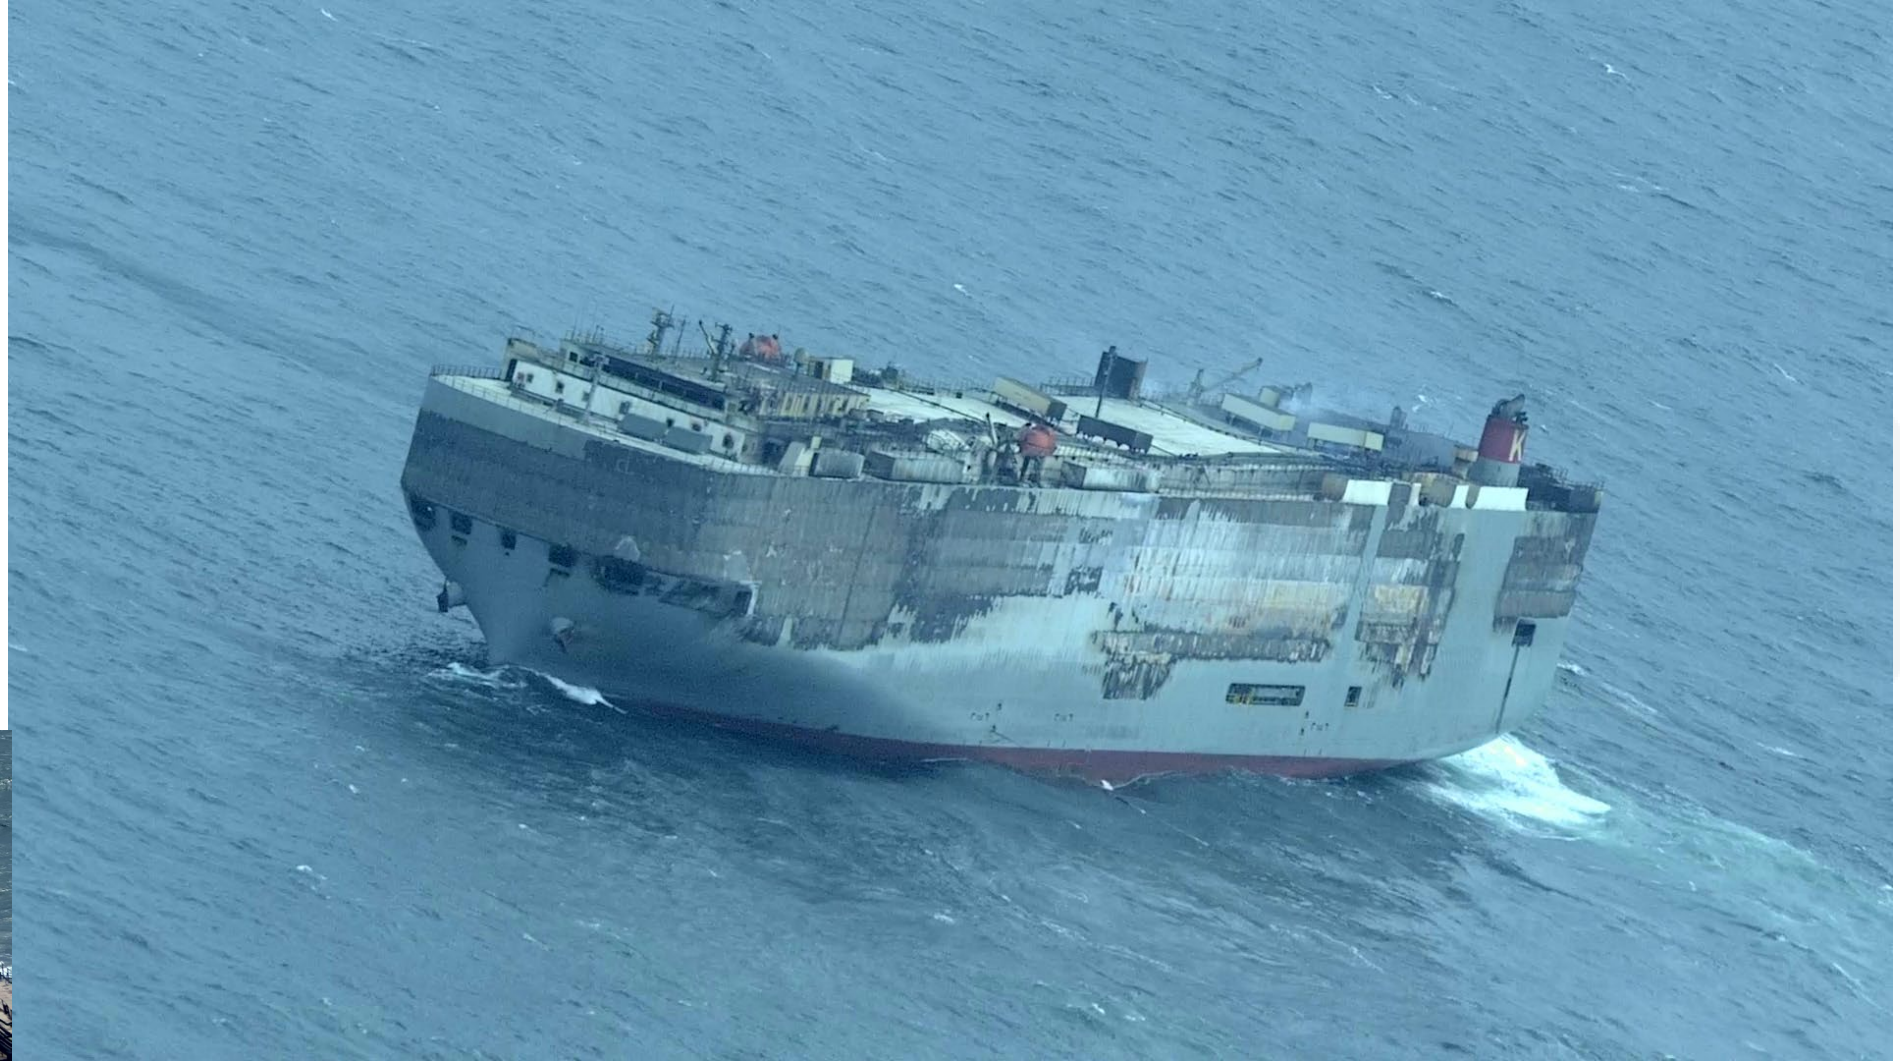
30 July 2023 – Upper deck heavily displaced.

30 July 2023 – Bridge and accommodation consumed by fire.

30 July 2023 – Smoke still evident.

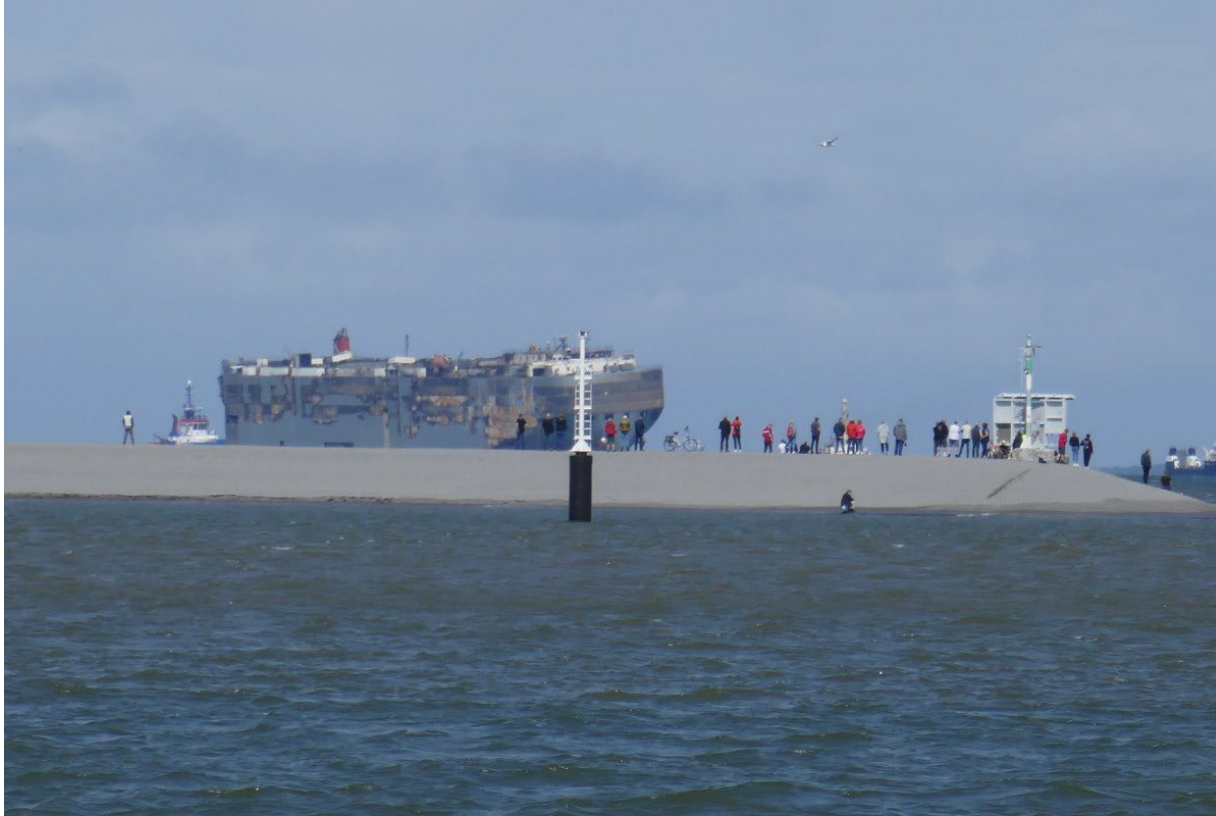
2 August 2023 – Agreement for FREMANTLE HIGHWAY to berth in Eemshaven.

3 August 2023 – Two pilots landed onboard by Helicopter.
