Ardmore Shipping

Georgina Alderman – Insurance Manager

Findings of the IGP&I Clubs report for claims involving vessels under pilotage during the period between 1999 and 2019:

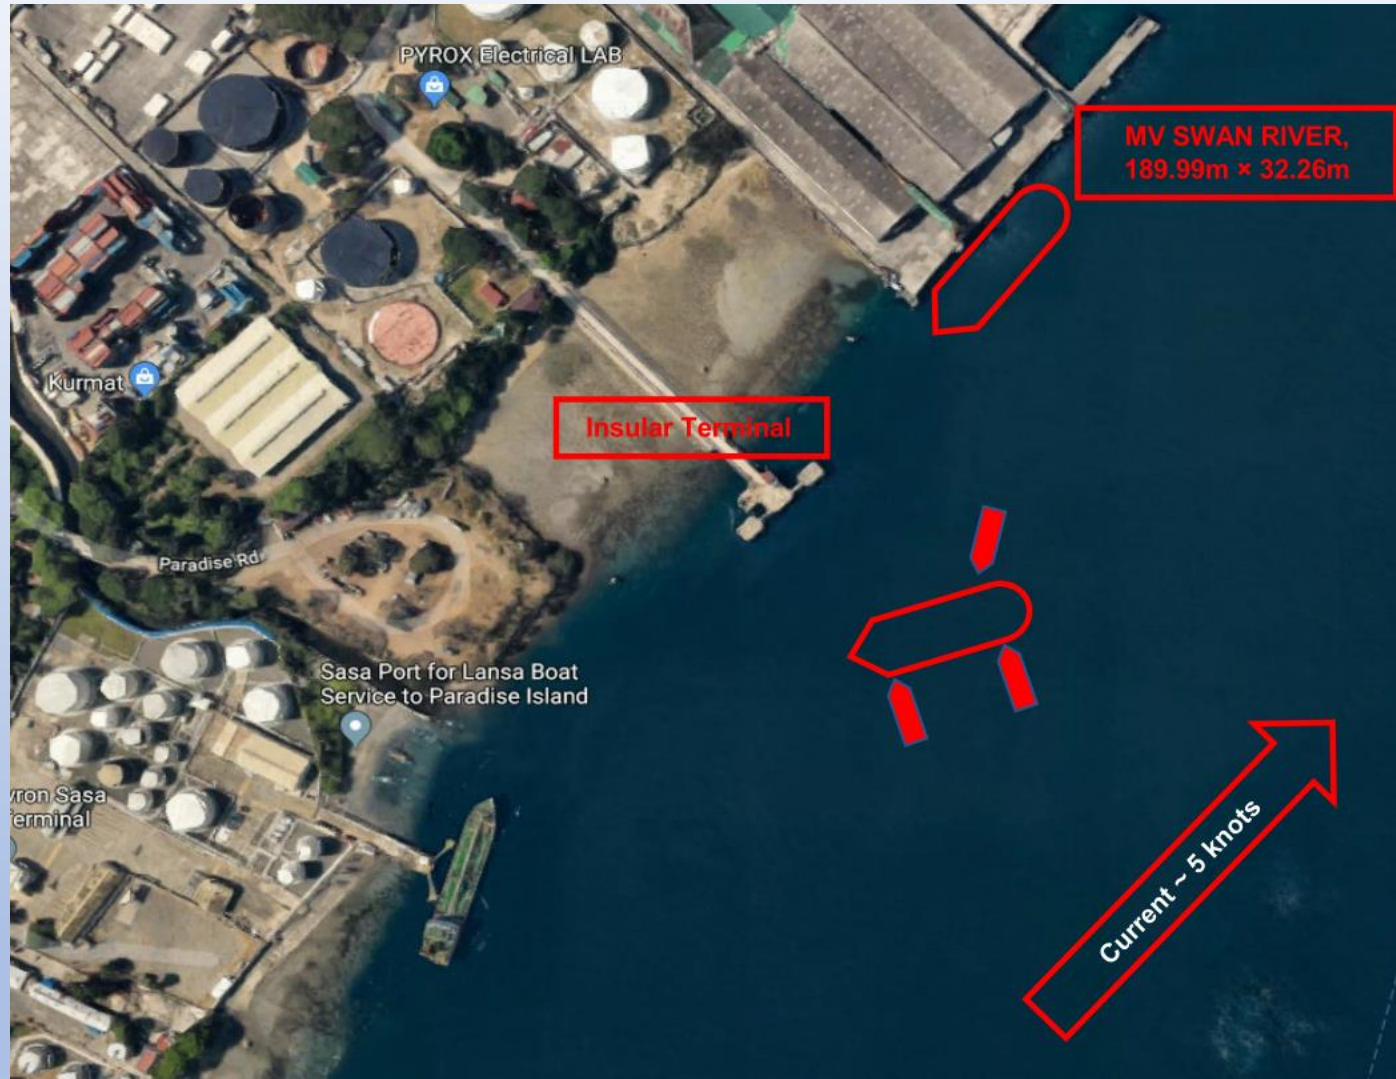
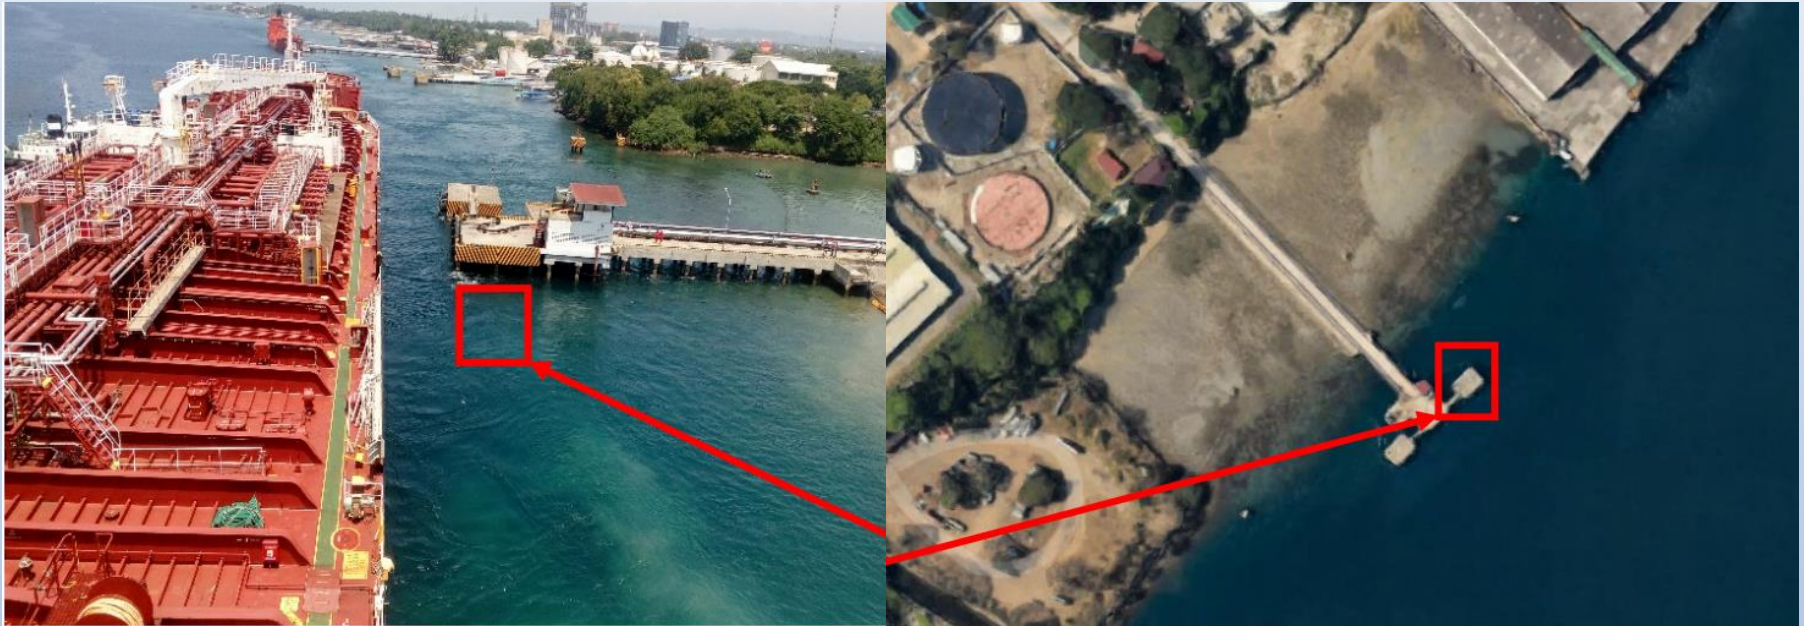
Dolphin Collapse During Berthing:

- Laden condition
- First call to the terminal
- Information from agent was poor – no terminal booklet provided. Berth had been upgraded but berthing plan does not appear to have been amended to take in to account larger vessels
- Only restriction was daylight berthing only
- 3 tugs provided
- Actual current off the berth was more than twice that anticipated
- Approach to the berth was compromised by another vessel berthed astern – the angle of approach was too steep - 30 degrees
- The lateral speed of approach was too great - the tugs were unable to reduce the speed sufficiently
- The vessel made hard contact with the main terminal and 2 dolphins. The aft dolphin subsequently collapsed

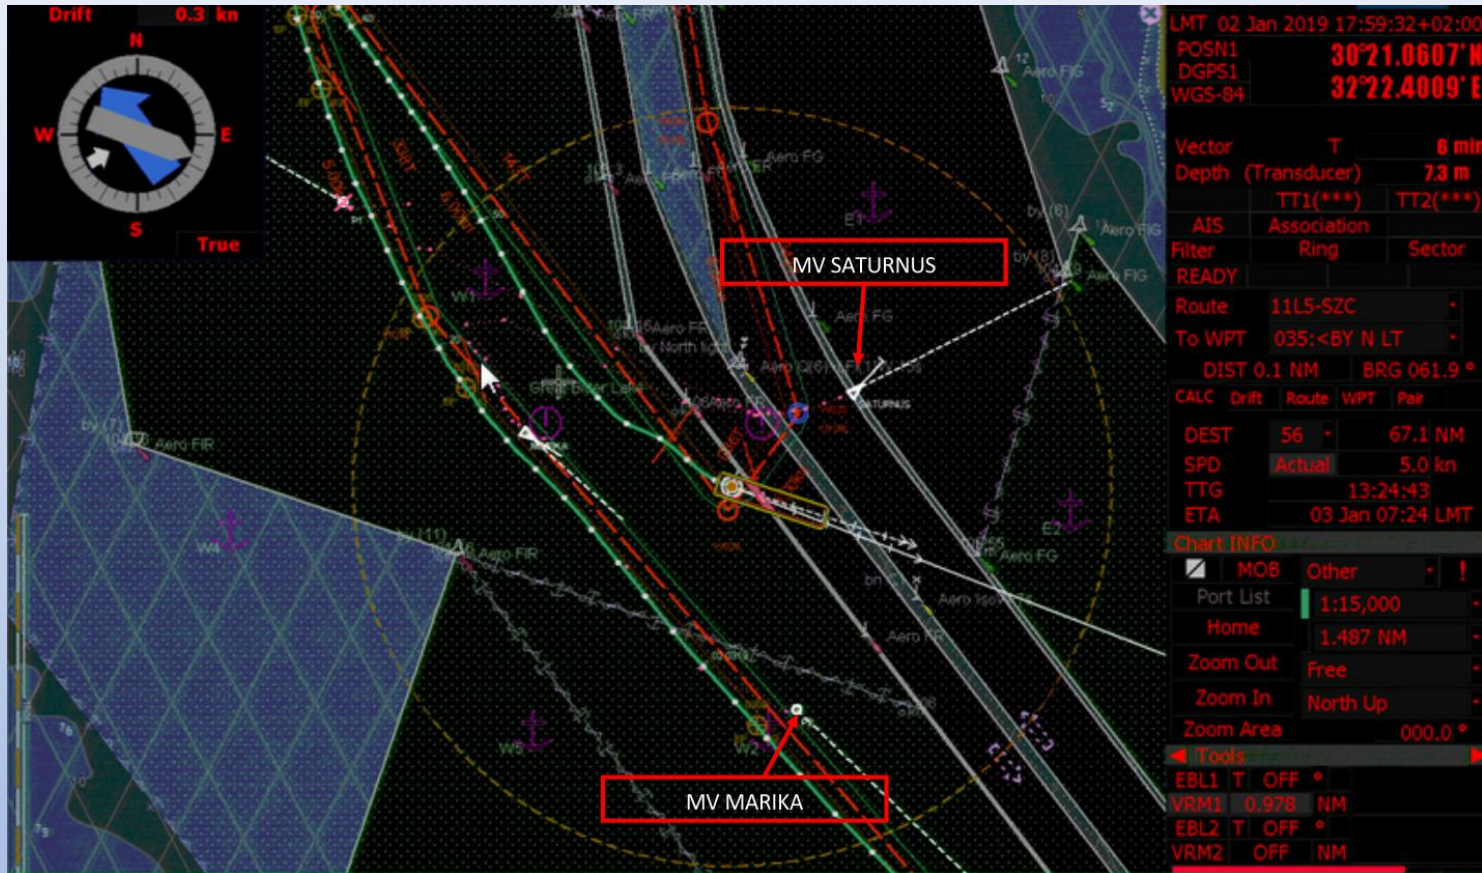
Suez Canal Grounding:

Vessel heaved up anchor from W1 anchorage (Great Bitter Lake) and was proceeding to join the East Channel. Vessels MV Saturnus in front with MV Marika astern.

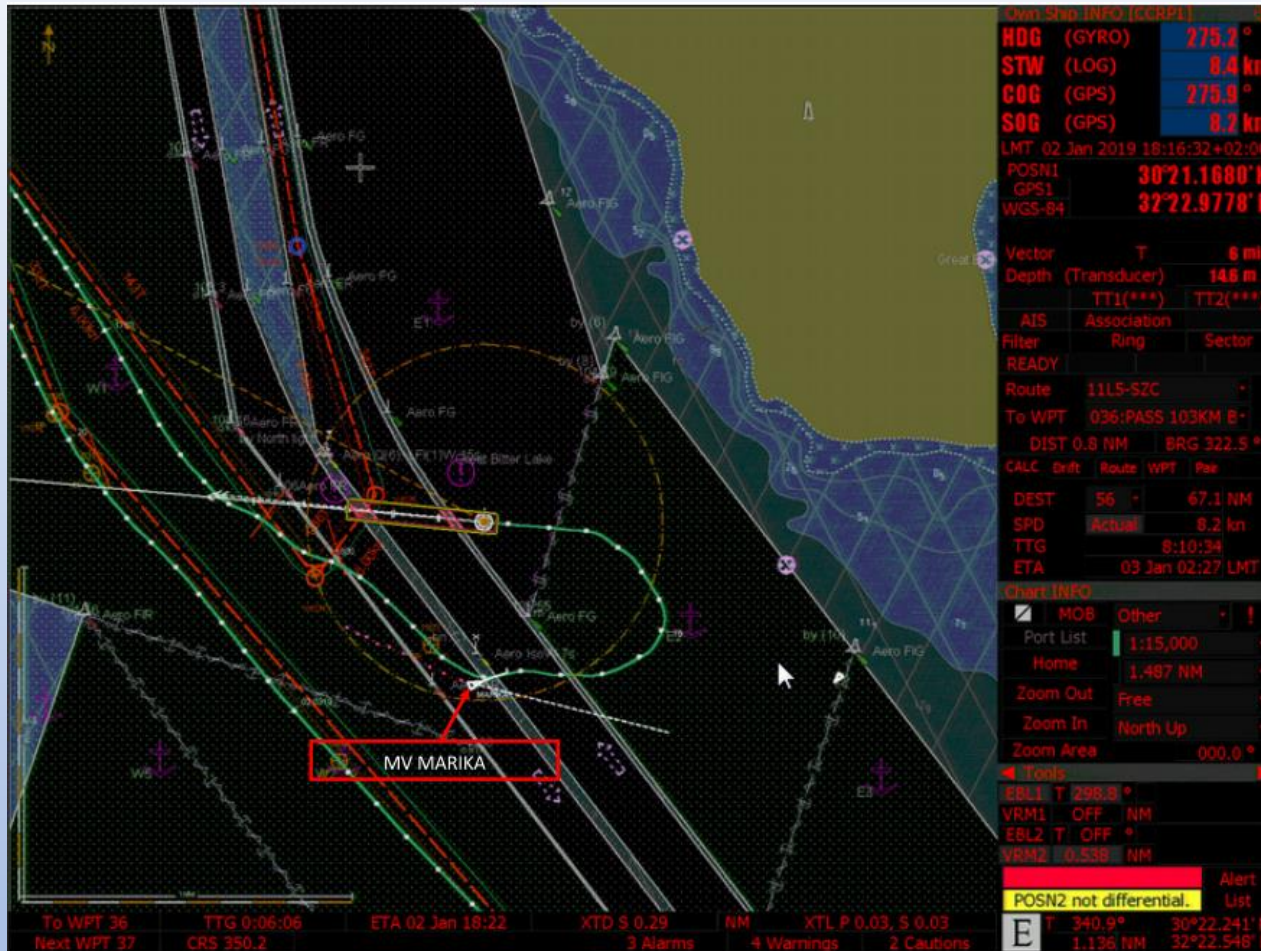
At this point, the pilot informed the Master that the vessel will be taking the West Channel instead of the East Channel

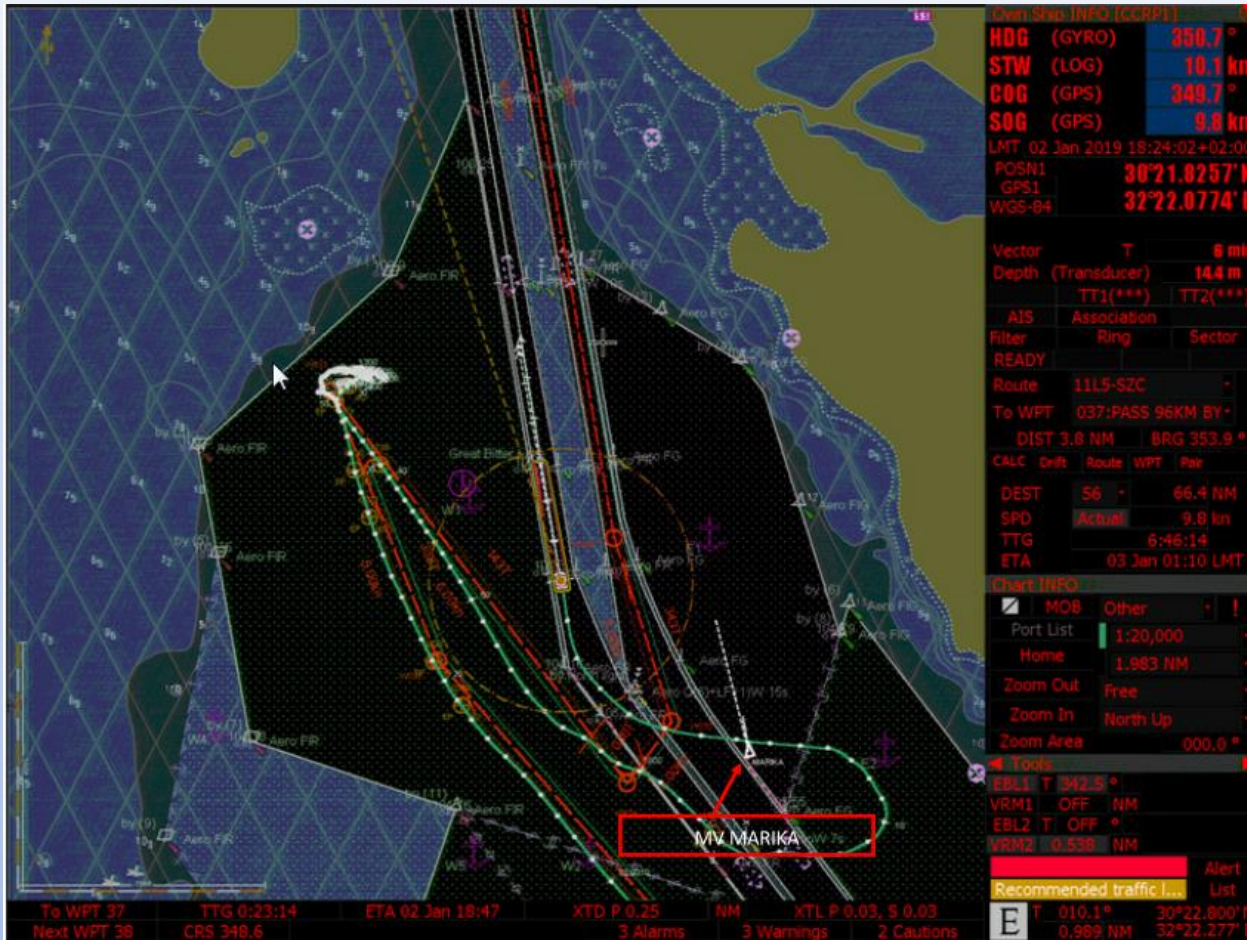
Own vessel joined the west channel and the MV Marika was en route to joining the east channel. At this point pilot requested full ahead and any additional RPM, if possible.

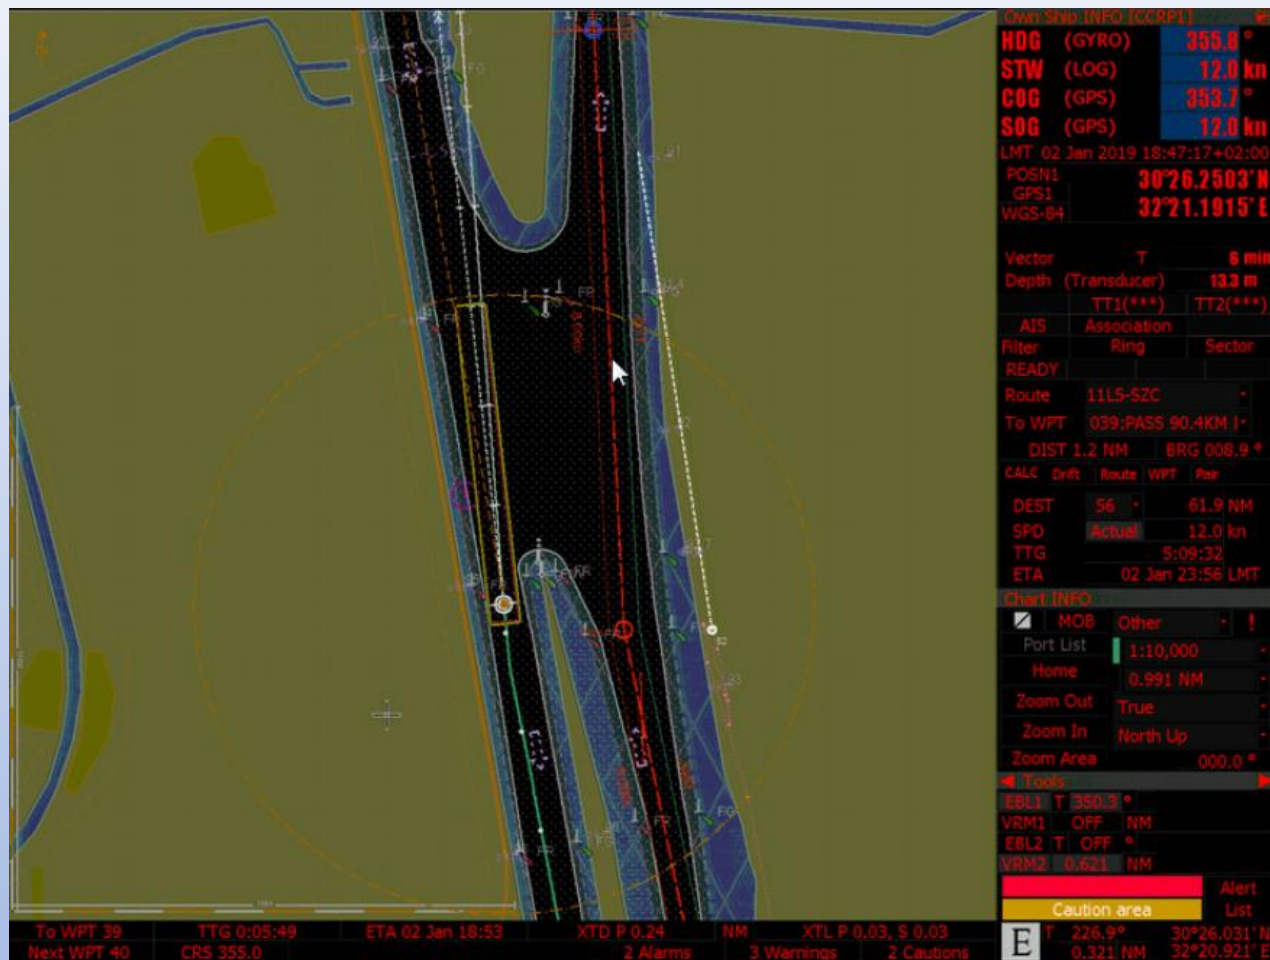
Pilot commences turn to starboard to join the east channel.

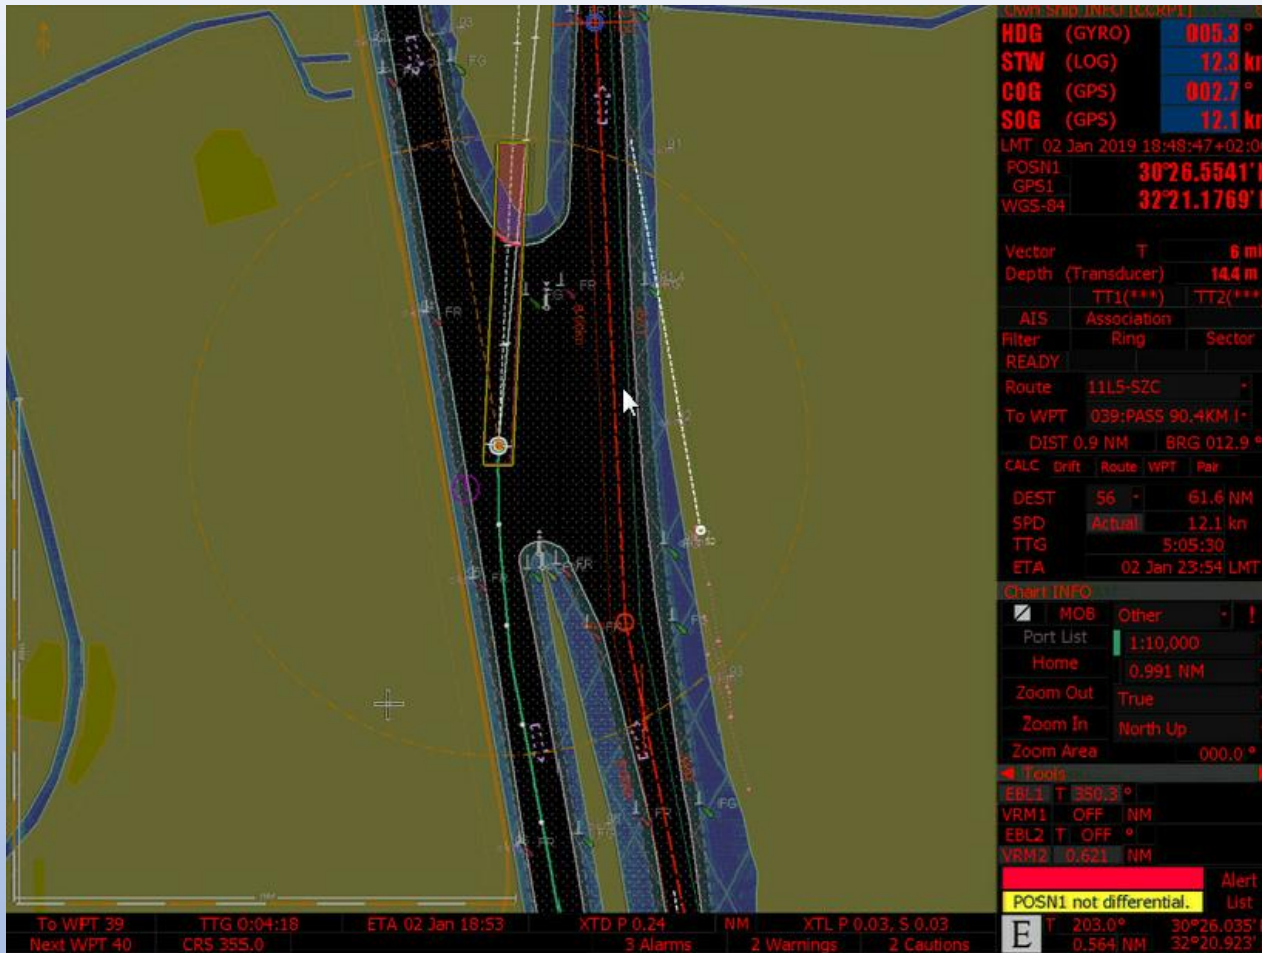
Pilot continued to turn to starboard to join the east channel.

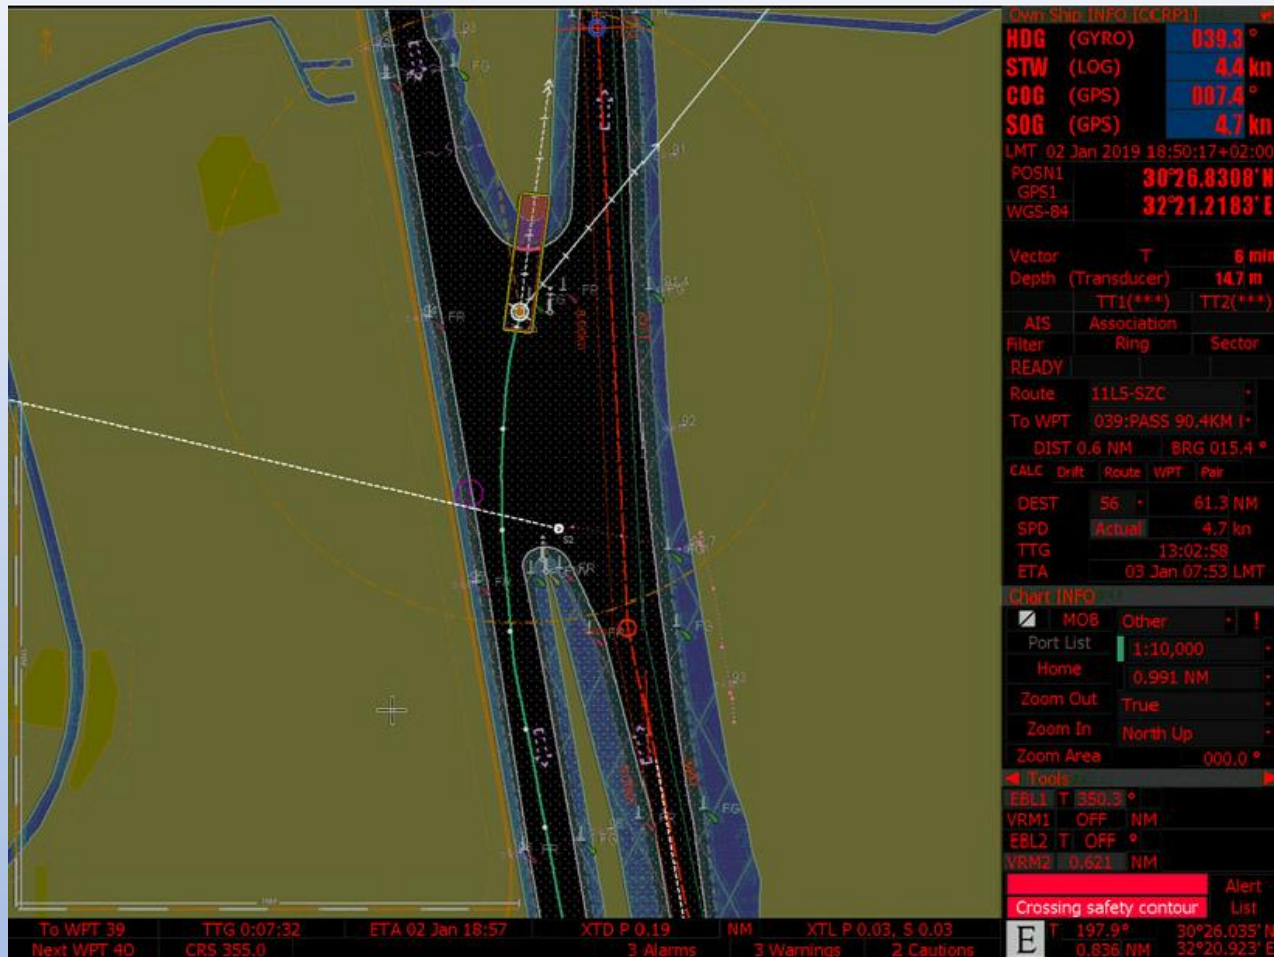
Vessel grounded at the sand bank, bow first at a speed of 12.2 knots.

- Failure to comprehend the turning circle of the partly laden vessel
- Manoeuvre commenced later than it should have been
- Excessive speed
- Helmsman was given 5 degree and then 10 degree course instructions instead of rudder angles

- Poor communication – between pilot / bridge team / Master
- Pilots communication with SCA was not in English
- Master did not seek clarification
- Not sufficient time to update passage plan for using southbound/west channel
- Inadequate intervention by bridge team
