CRISIS MANAGEMENT – Pilotage in Challenging Circumstances

Considerations and challenges when Risk Assessing an unusual Situation

V DUE - Liverpool, UK – 2016

FREMANTLE HIGHWAY – Holland, 2023

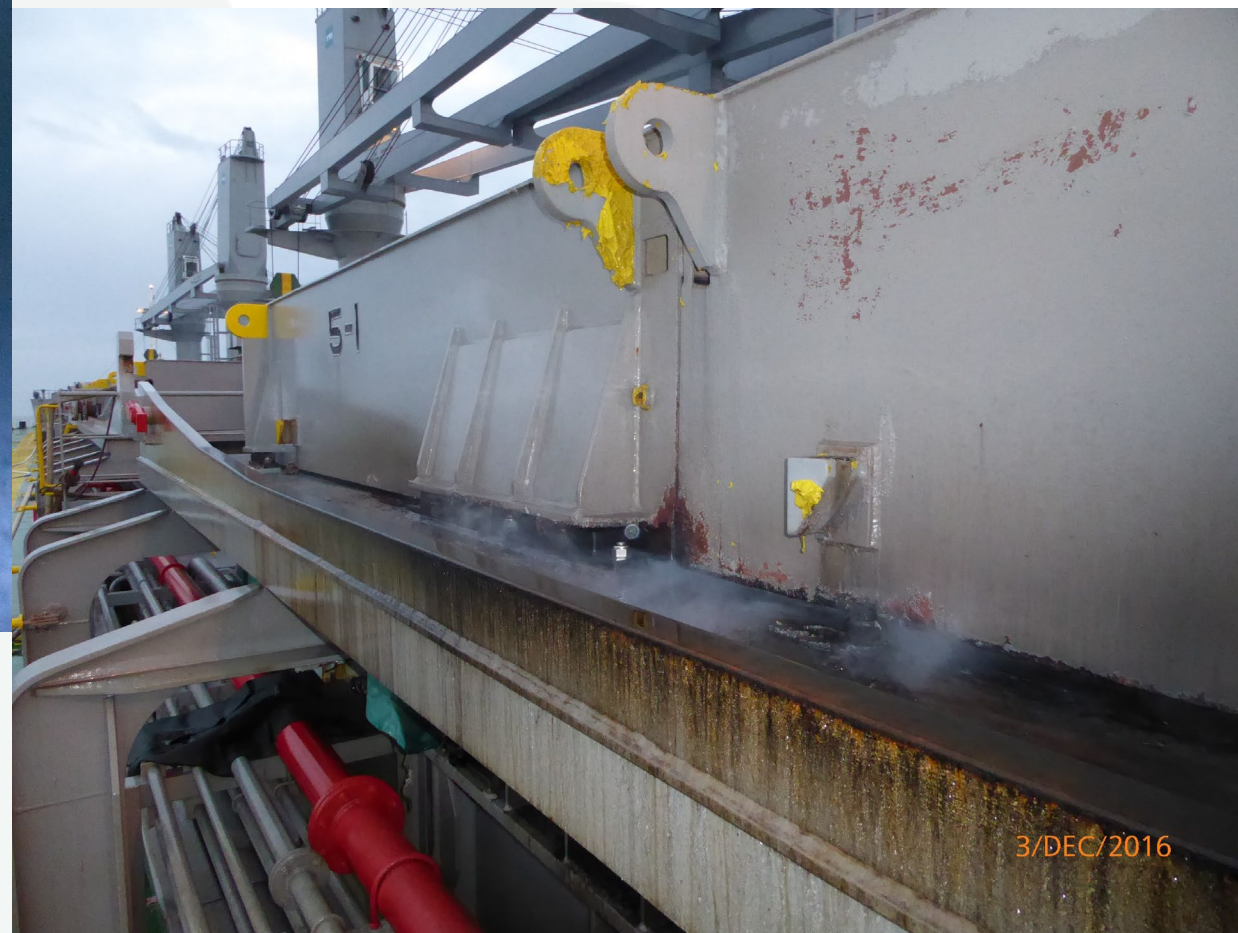
Salvors onboard Gas Reading on Deck

CO 114PPM adjacent to Hatch Cover

Smoke escaping through seals from overpressure in hold

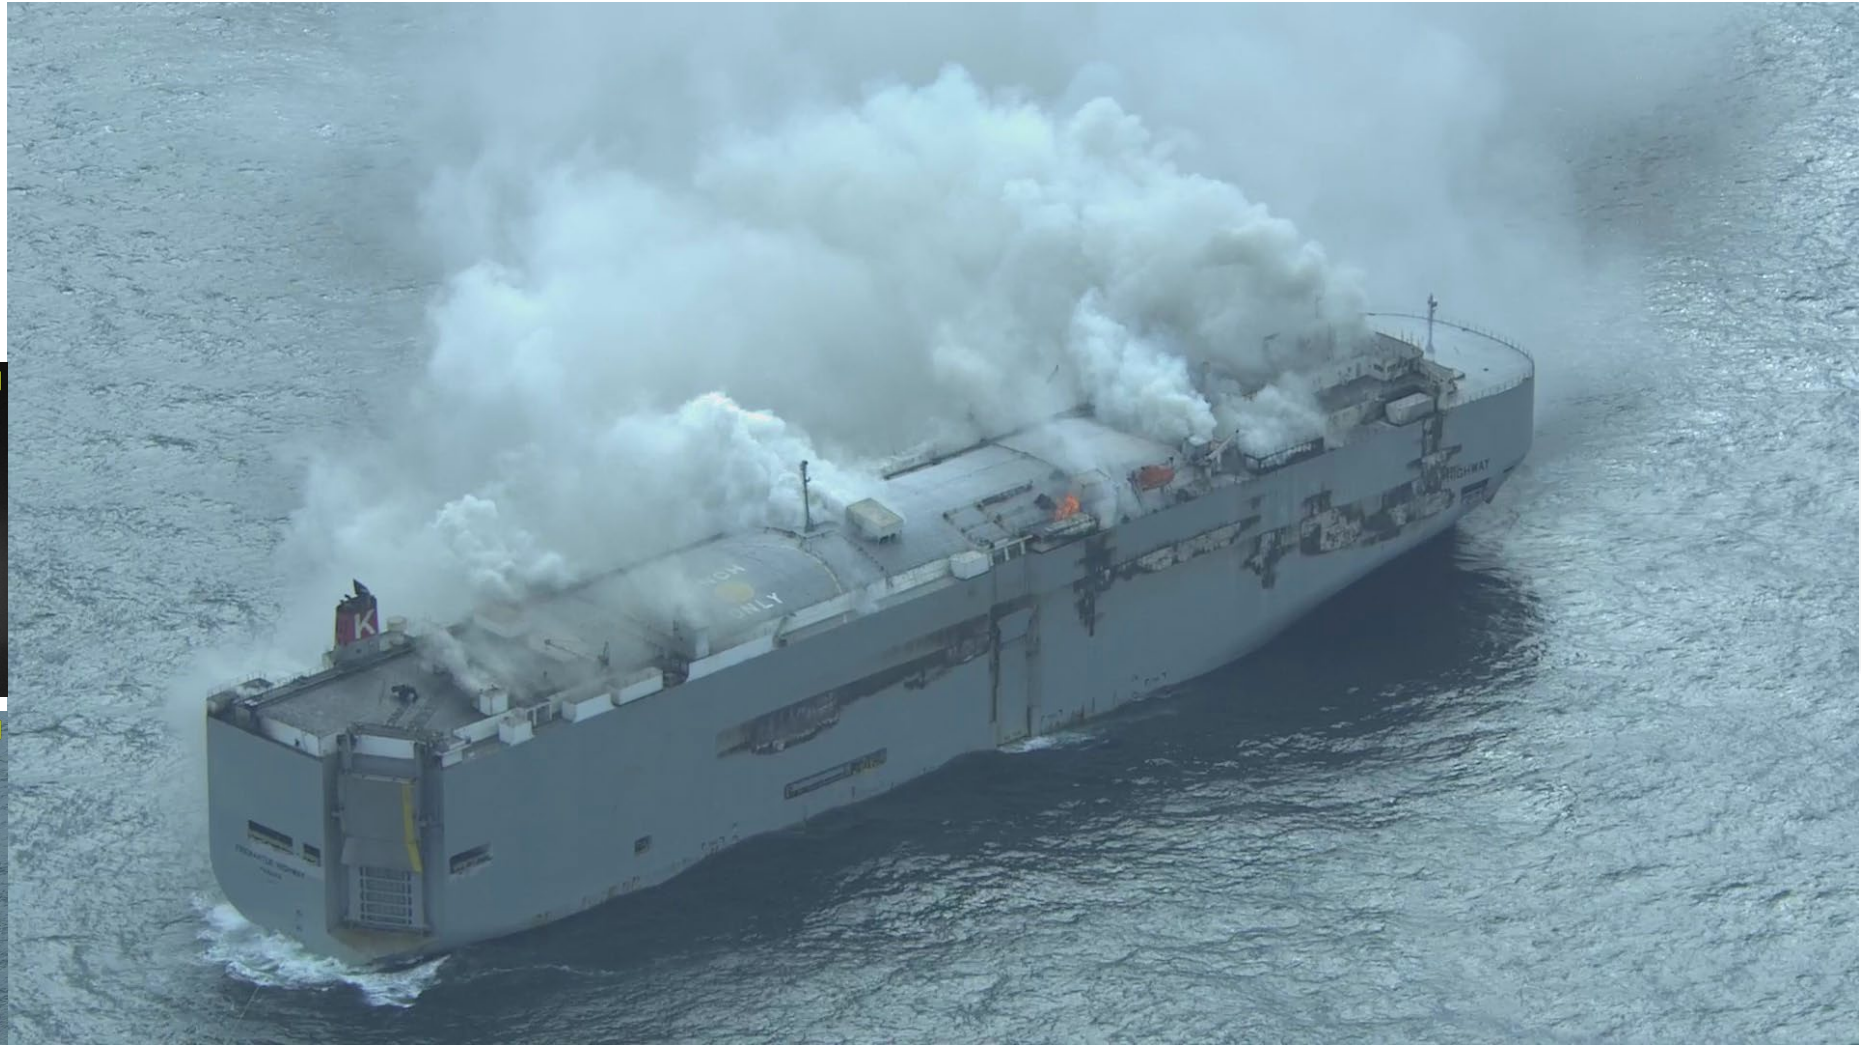
25 July 2023 – Fire identified within Car Deck of the vessel following departure from Bremerhaven.

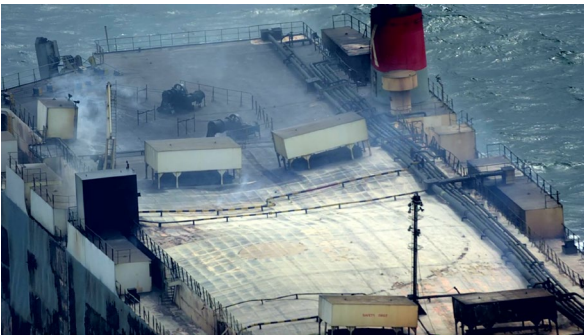
30 July 2023 – Upper deck heavily displaced.

30 July 2023 – Bridge and accommodation consumed by fire.

30 July 2023 – Smoke still evident.

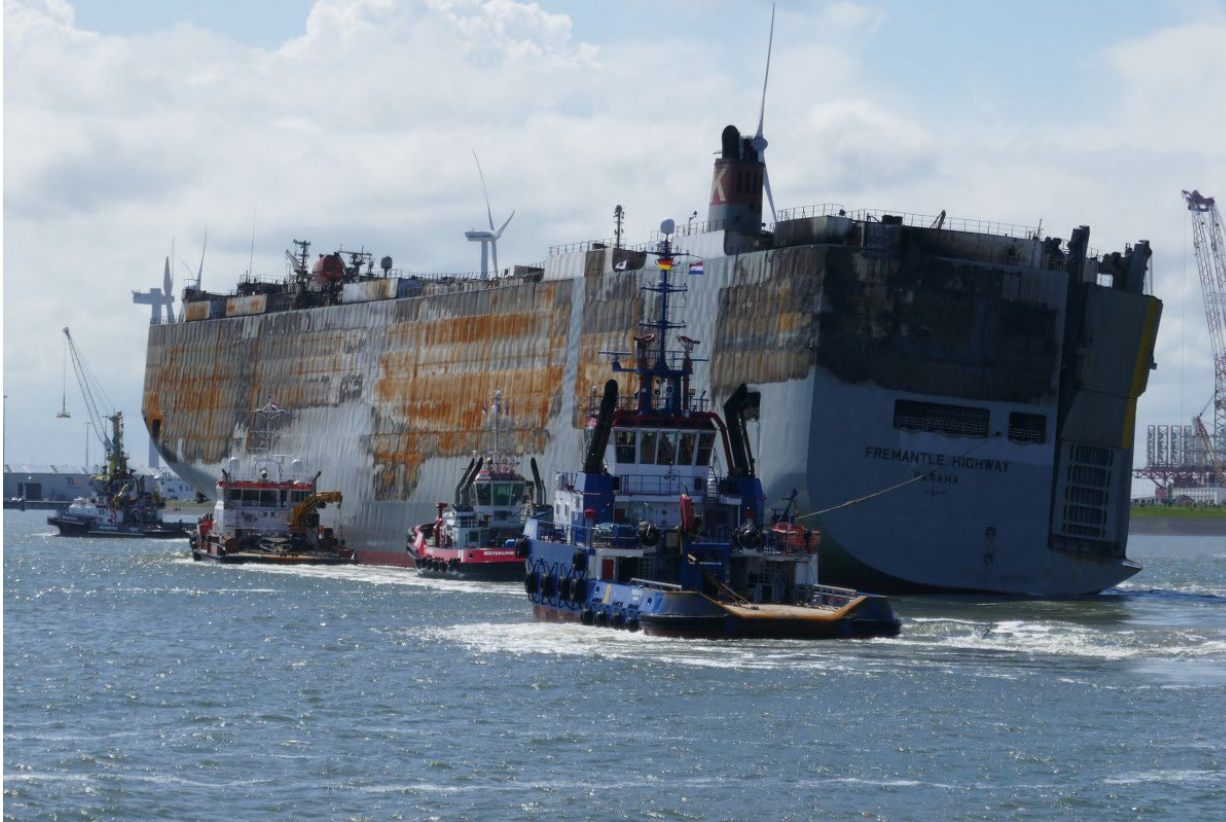
1. Three Pilots Required
2. Two Pilots onboard casualty
3. One pilot on Supporting Tug
4. Two Tugs connected (MULTRATUG 20 & FAIRPLAY 30)
5. One Salvage Support Vessels (MULTRASALVOR 4)
6. Two Salvage Support Tugs (GUARDIAN & BARNEY)
7. Two Harbour Tugs

1. Bridge and accommodation burnt out
2. Access to Bridge Deck would be through Toxic Cargo Decks or from External means
3. No facilities on board whatsoever
4. Dead Ship (no power, no lighting, no propulsion etc)
5. Five degree list to Starboard.
6. 220m
