Ardmore Shipping

Georgina Alderman – Insurance Manager

Findings of the IGP&I Clubs report for claims involving vessels under pilotage during the period between 1999 and 2019:

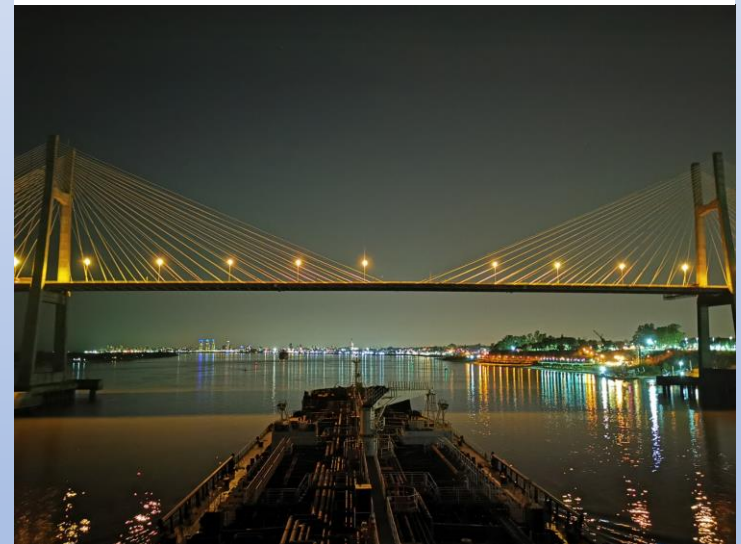
Dolphin Collapse During Berthing:

- Laden condition
- First call to the terminal
- Information from agent was poor – no terminal booklet provided. Berth had been upgraded but berthing plan does not appear to have been amended to take in to account larger vessels
- Only restriction was daylight berthing only
- 3 tugs provided
- Actual current off the berth was more than twice that anticipated
- Approach to the berth was compromised by another vessel berthed astern – the angle of approach was too steep - 30 degrees
- The lateral speed of approach was too great - the tugs were unable to reduce the speed sufficiently
- The vessel made hard contact with the main terminal and 2 dolphins. The aft dolphin subsequently collapsed
